TECHNICAL REPORT REMR-CS-6

**IN SITU REPAIR OF DETERIORATED
CONCRETE IN HYDRAULIC STRUCTURES:
FEASIBILITY STUDIES**

R. P. Webster, L. E. Kukacka

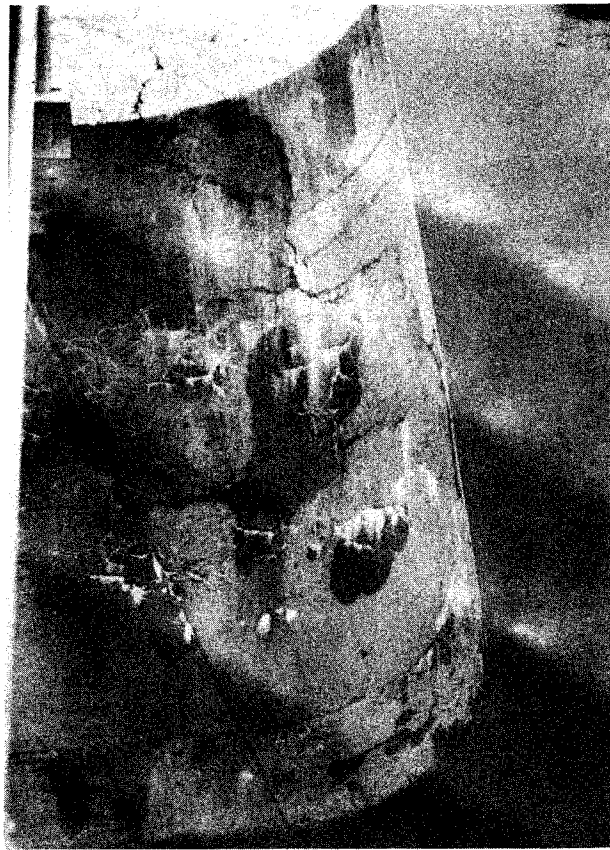
Figure 1. Typical cracking deterioration in concrete gate piers.

a. General view of deterioration due to cracking.

b. Closeup view of top of gate pier.

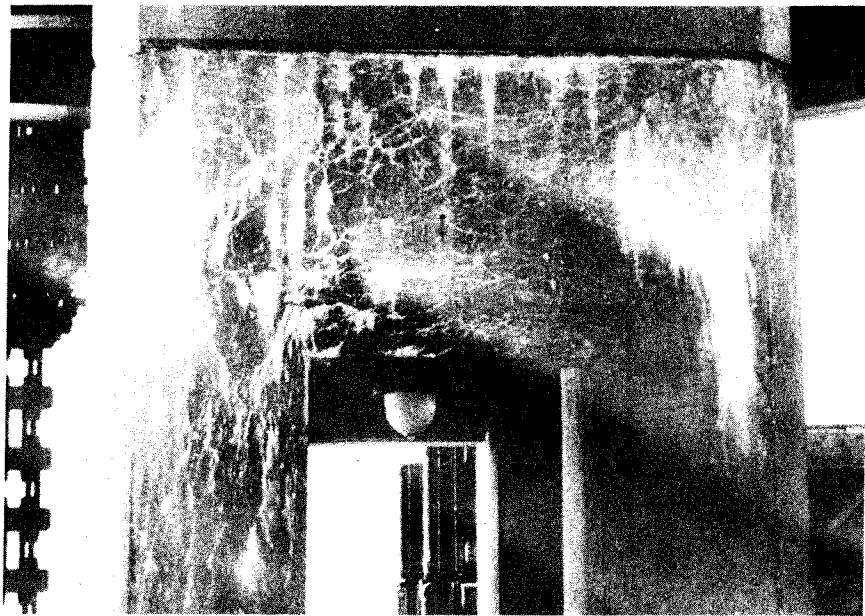
Figure 2. Typical cracking in concrete arch.

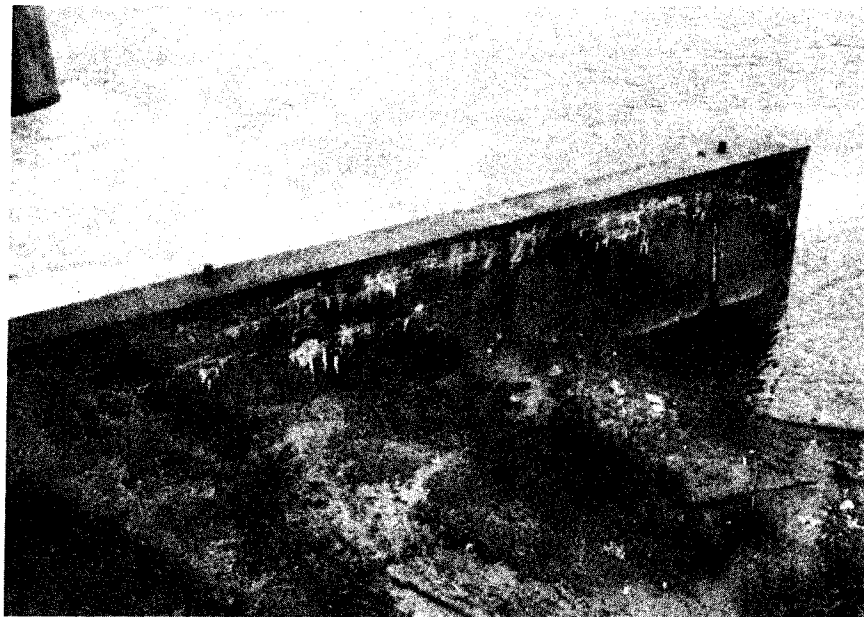
Figure 3. Typical cracking in concrete wall.

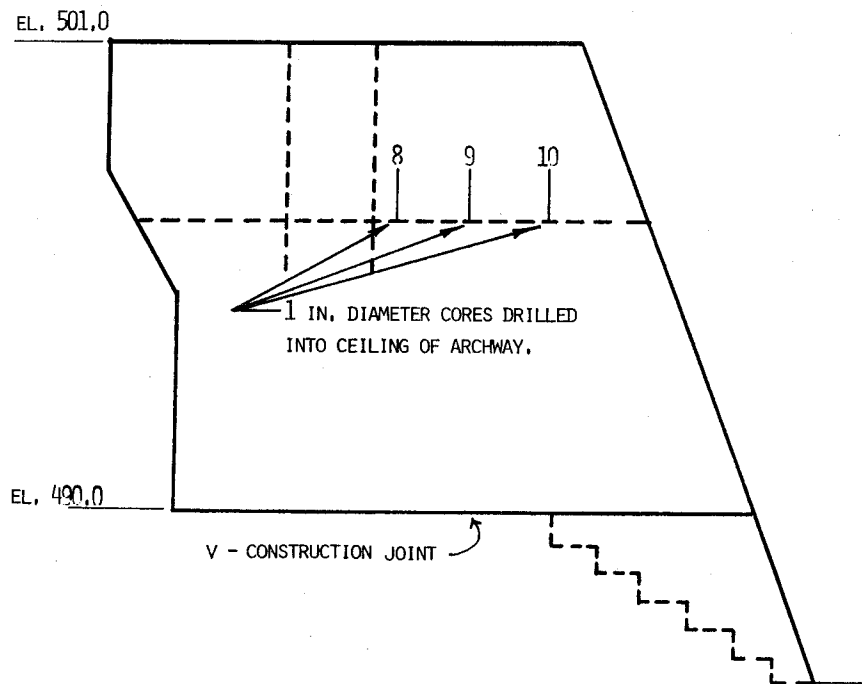
Figure 10. East elevation showing location of injection ports (Flock and Walleaser, 1983).

Epoxy injection was started in the middle of the archway ceiling at Port No. 9 (refer to Figures 10-12). Pumping was continued, while the epoxy reached injection Ports Nos. 2, 3, and 12 on the downstream face. The operation was then moved to the upstream ceiling port (No. 8). The contractor had difficulty maintaining a seal around the injection packer. In addition, leakage of epoxy was noted at the bottom edge of the access manhole and adjacent to the electrical conduits embedded in the archway ceiling. An attempt was made to inject epoxy into Port No. 10; however, it was impossible, even at a pressure of 160 psi.

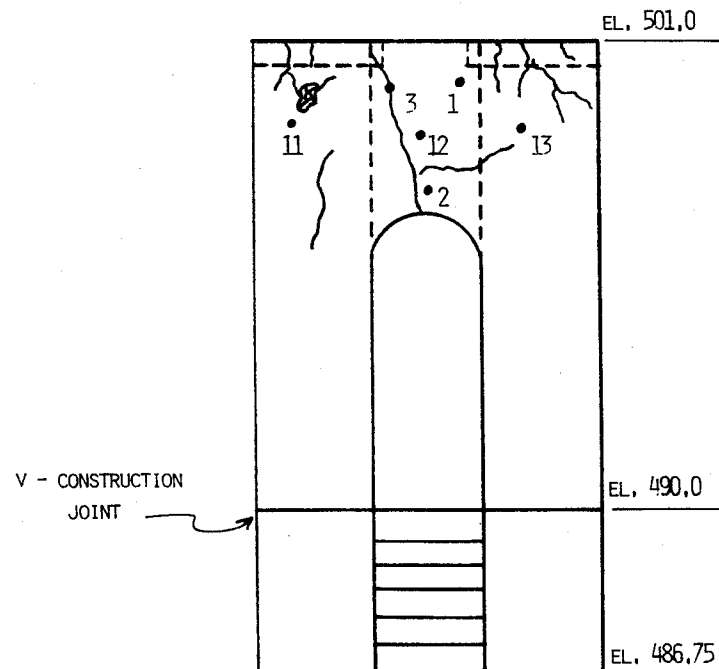
Figure 11. Downstream view showing major cracks and locations of injection ports (Flock and Walleser, 1983).

The injection operation was then moved to Port No. 12 on the downstream face. Again, problems were encountered with leakage at the packer seal. Injection was moved to Port No. 11. Leaks through the seal coat developed at pop-outs and along wider cracks on the downstream face. As epoxy was pumped into the pier, water was driven from the cracks and appeared on the surface of the pier at elevations below the seal coat. Epoxy also appeared at several small cracks in these areas. Injection was continued at Port No. 13, then at Port No. 1. Epoxy ponded at the top of the downstream east grout pad while pumping at Port No. 1. Injection was continued at Port No. 6 on the pier top. The last port injected was No. 7, also on top. This port was injected until epoxy appeared at the handhold at the top of the access manhole. The injection packers were then removed and all ports were sealed with epoxy. The pier was injected for a total time of approximately 34 hours. Approximately 8.4 gal of epoxy were injected into the pier.

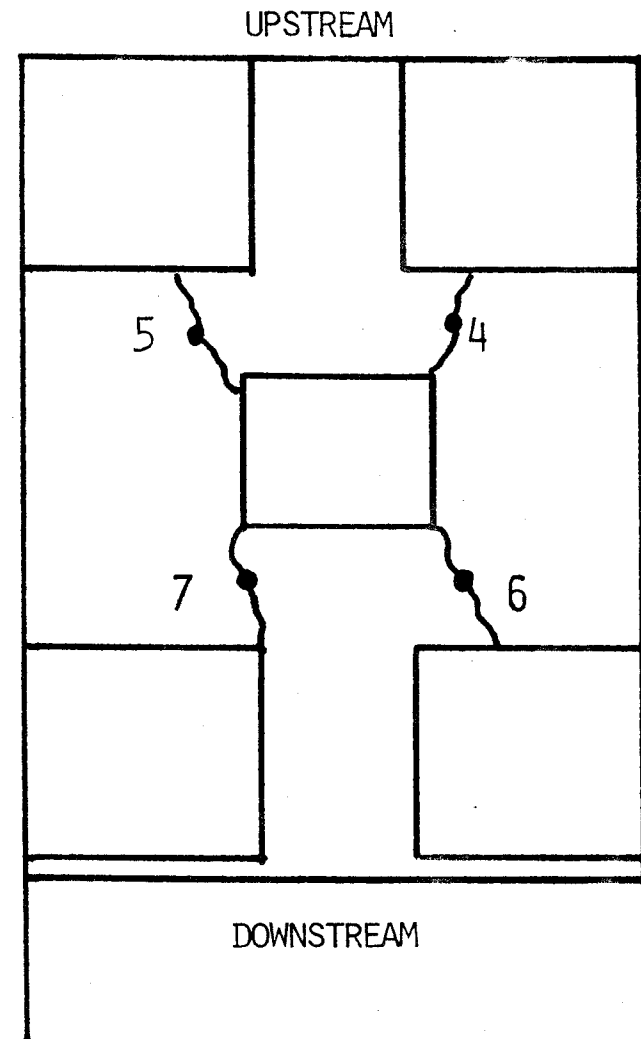
Figure 12. Top view showing major cracks and locations of injection ports (Flock and Walleser, 1983).

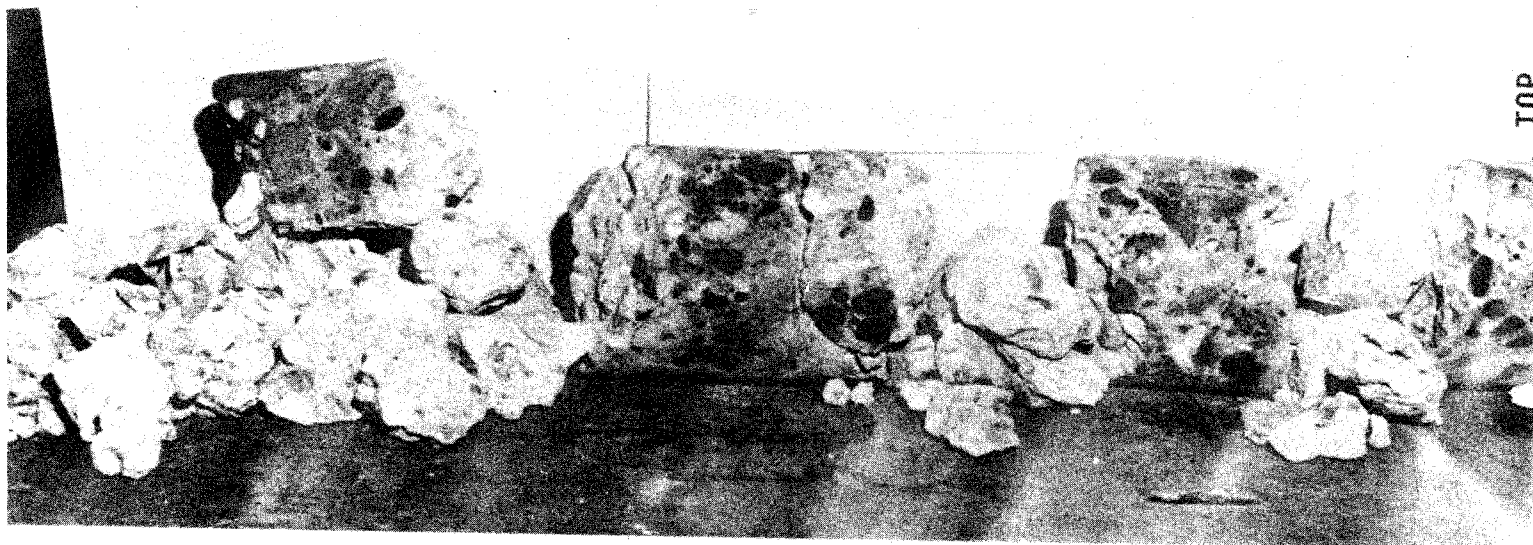
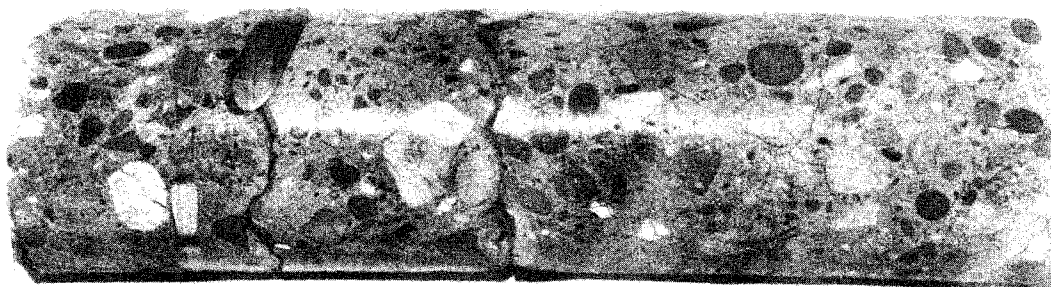
Figure 13. Cores taken from Pier 39 before and after epoxy injection.

Upon completion of the pulse velocity tests, concrete cores were taken from various locations to further evaluate the effectiveness of the repair. Presented in Figure 13 are photographs of cores taken before and after the pier was repaired. Cores removed from the pier top contained numerous random and crudely parallel diagonal cracks as well as many fractured aggregate particles. Only 5 to 10% of the cracks were filled with epoxy, explaining the difficulty in obtaining pulse velocity readings.

#2 10-14-82
EPOXY INJECTED
HORIZONTAL CORE
D/S FACE OF PIER

The cores taken from the downstream face were not as severely cracked as the core removed from the pier top. The cracks were finer and more randomly distributed throughout the length of the cores. Fifty to ninety-five percent of the cracks were filled with epoxy. Tests for resistance to freezing and thawing subsequently run on two of these cores indicated the epoxy injection was successful in rebonding the concrete and in holding it together under freezing and thawing conditions. Most of the failure observed in these tests resulted from crumbling of the non-air entrained mortar and cracking of the coarse aggregate particles. In general, it was concluded that the epoxy in the fractures tended to hold the concrete together during the freezing and thawing cycles and aided in slowing down the deterioration of the concrete. Based on the tests, the performance of the concrete in the structure cannot be predicted absolutely; however, it is expected that while the exposed concrete surface would be subjected to damage due to freezing and thawing, the deeper interior concrete may be cemented together well enough to form an integral whole and to perform satisfactorily.

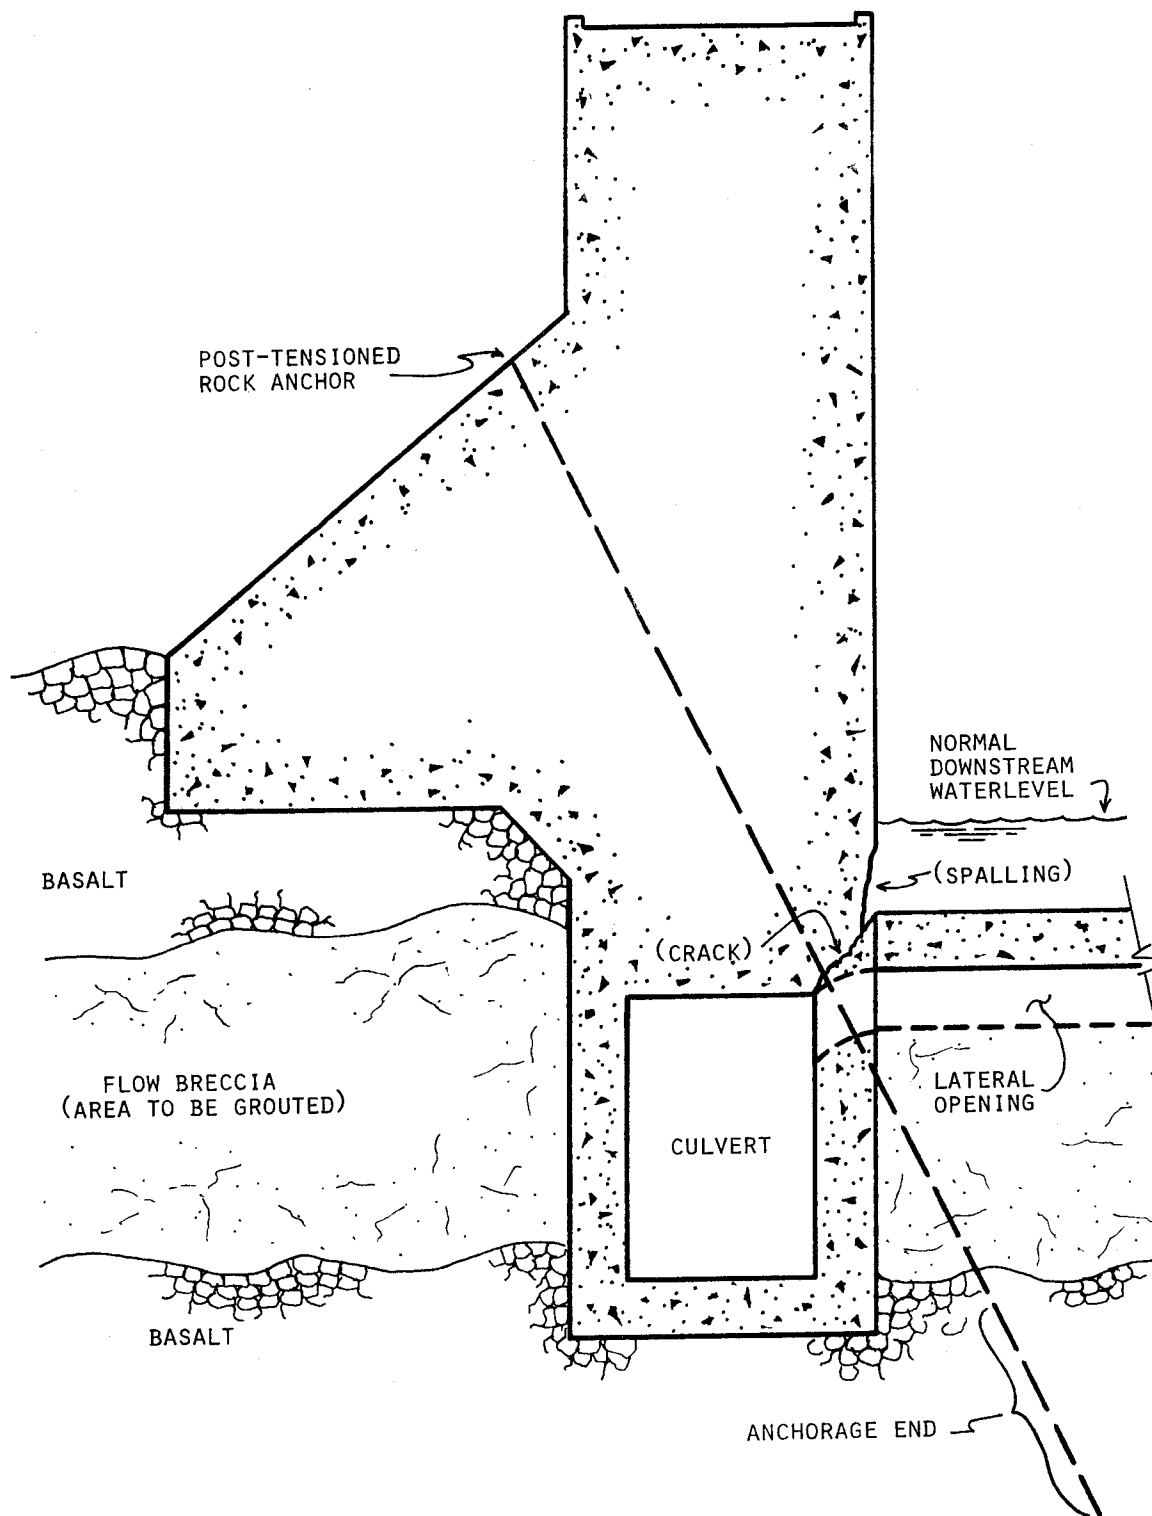
During an inspection in 1975, significant structural cracking and related spalling were discovered in two of the lock monoliths, monoliths 17 and 19. By 1979, cracking and spalling had been detected in four additional monoliths, monoliths 13, 15, 21, and 23. The structural distress in the monoliths consisted of cracks that originated at and propagated from the upper inside corner of the filling and emptying culvert and terminated at the surface of the wall in the lock chamber. Because of the continued progression of the cracking and spalling, a series of remedial repair procedures were devised and implemented to halt and correct the ongoing deterioration (Adhesive Engineering Bulletin, 1981b, Barlow, 1986, and Neuberger, 1982).

Figure 15. Cross-section of lock wall, showing details of crack location and supporting rock mass.

In 1981, Phase Two of the repair program was performed. This phase of the repair program involved the installation of 73 rock anchors and the injection of structural epoxy adhesive into the crack network. Finite element analysis had shown that the forces induced by the rock bolt anchors would substantially reduce the tensile stresses in the cracked areas at the top of the culvert.

Subsequent to the grouting of the foundation, 10-in. diameter rock anchor holes were drilled from the outside of the monoliths into the basalt rock below. This work was carried on without interrupting lock
